TECHNICAL REPORT GL-85-5

THE VAIONT SLIDE, A GEOTECHNICAL ANALYSIS BASED ON NEW GEOLOGIC OBSERVATIONS OF THE FAILURE SURFACE

Volume I
MAIN TEXT

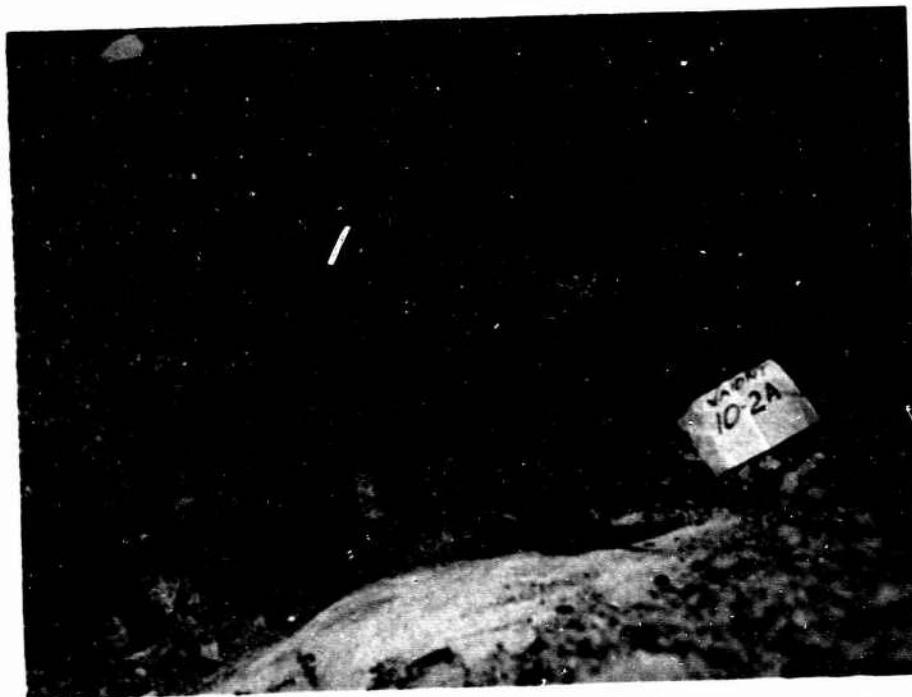
Photo 3. Close-up of three of the five clay interbeds at outcrop 8-1; thicknesses in cm: B - 17.5; C - 2-5; D - 3 (see Figure 14)

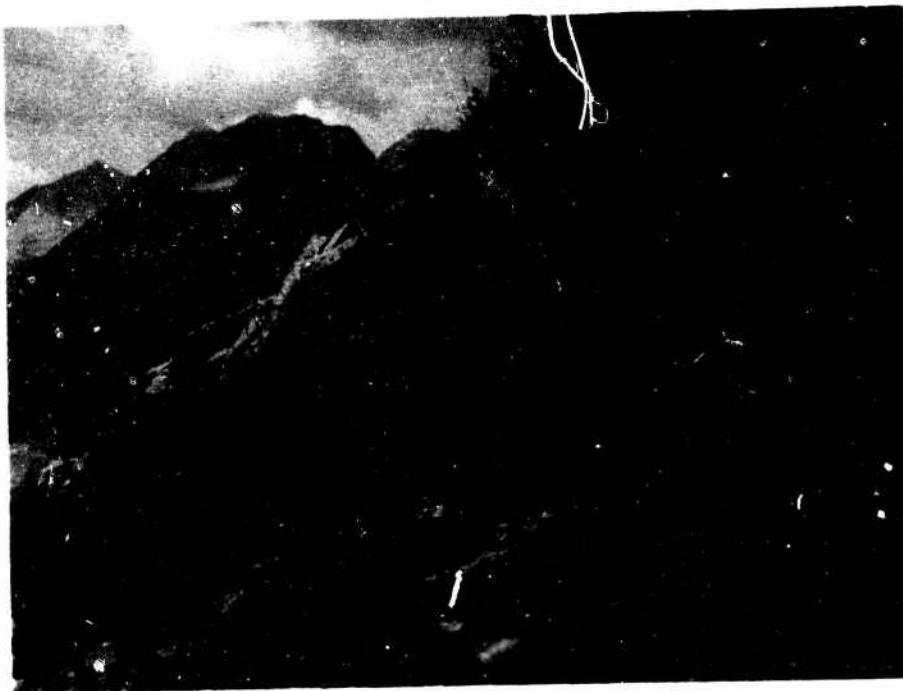
Photo 6. Location 10-4, western side of headscarp; slickensides were found in 1 to 2 cm thick clay layer at bedrock contact dipping at 23-24°N; holes indicate additional clay-rich materials in the overlying slide debris

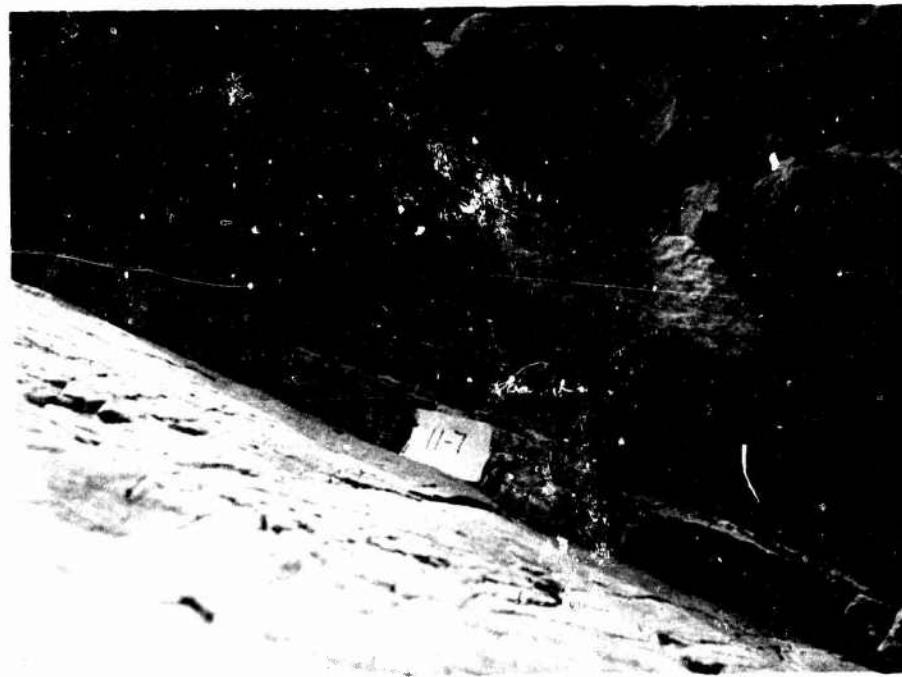
Photo 11. Location 11-7, lower portion of fourth gulley from west side of slide; clay layer 4 to 6 cm thick with a dip of 32-34°N forms the base of the slide debris; clay has been washed out below boulders

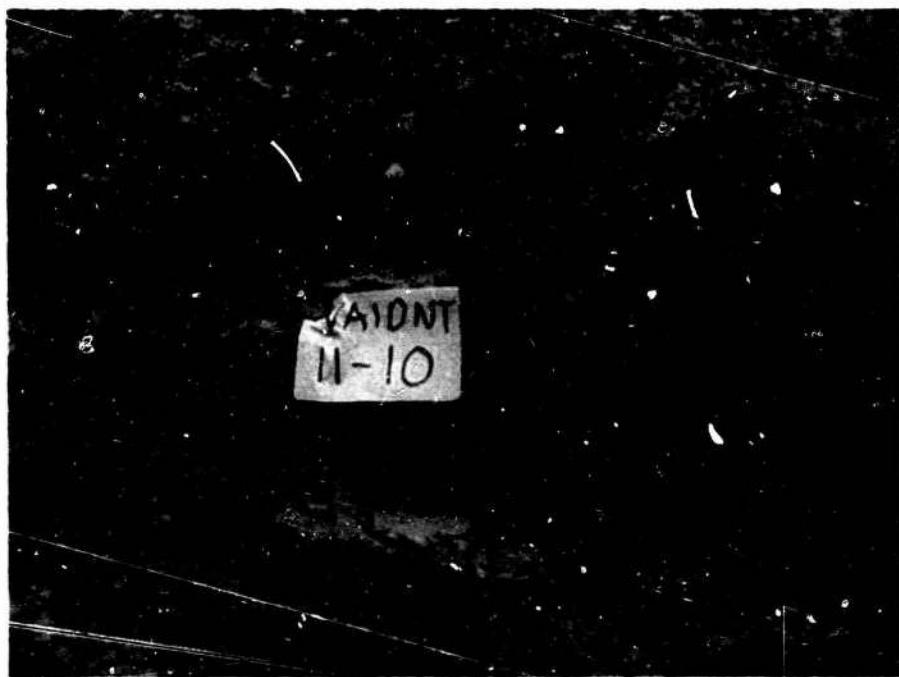
Photo 13. Location 11-8A (20 m above location 11-7B); clay layer along failure surface is 0.5 to 2 cm thick with a dip of 22° N

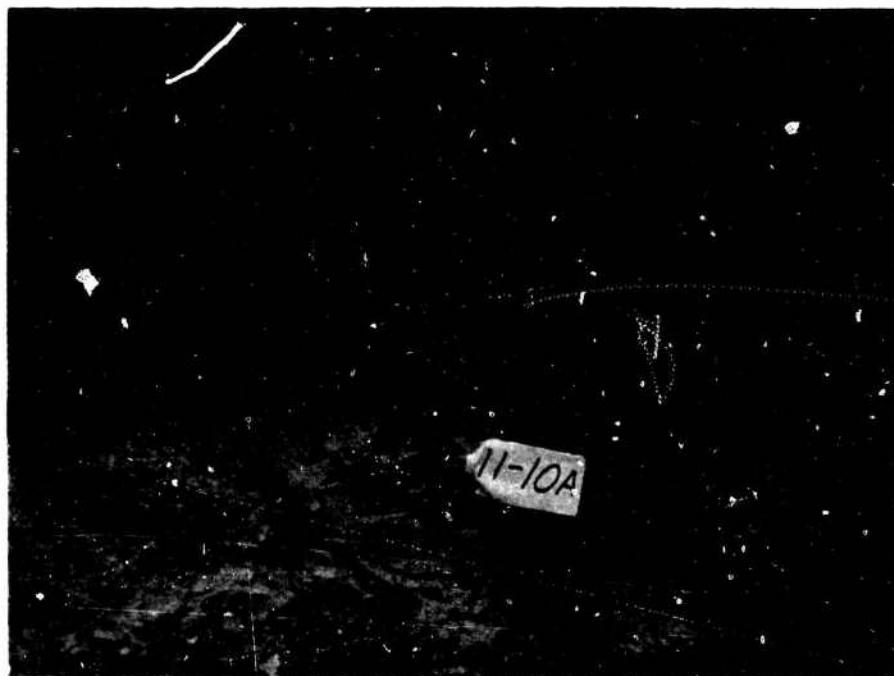
Photo 14. Location 11-10, fourth gulley from west side of slide; five layers of clay 1 to 2 cm thick lie in lower 1.5 m of slide debris; failure surface appears in lower left corner

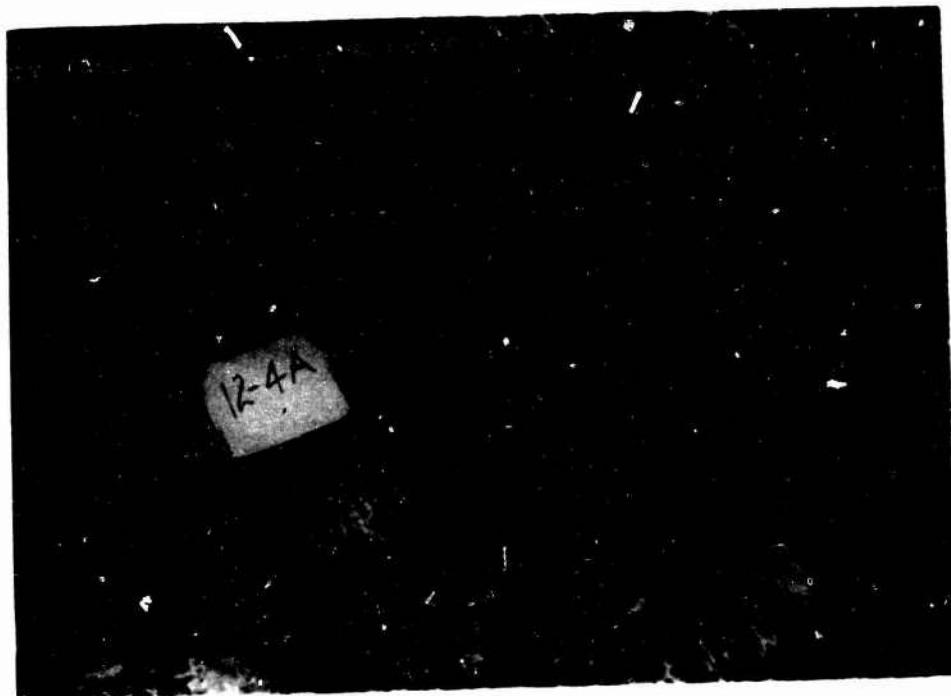
Photo 18. Location 12-4, near east side of slide approximately 70 m above location 12-3; clay layer 0.1 to 1.5 cm thick with a dip of 38° N is present on surface of sliding

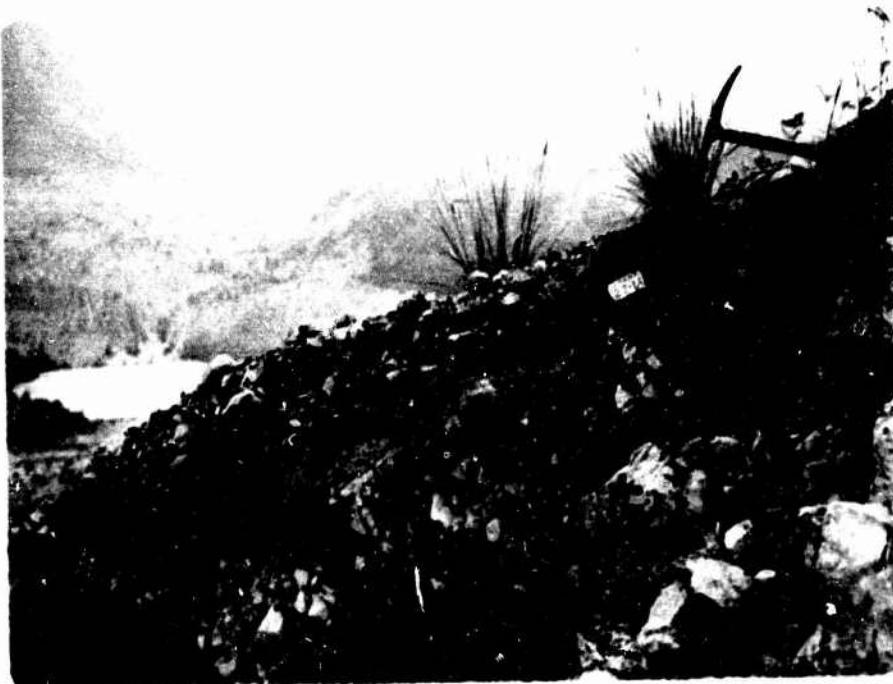
Photo 23. Location 22-1A, east side of fourth gulley from west side of slide; clay layer (with holes) is continuous with clay layer located in the lower 4 cm of debris on slope above; dip of clay layer 35° N; dip of surface of sliding 38° N

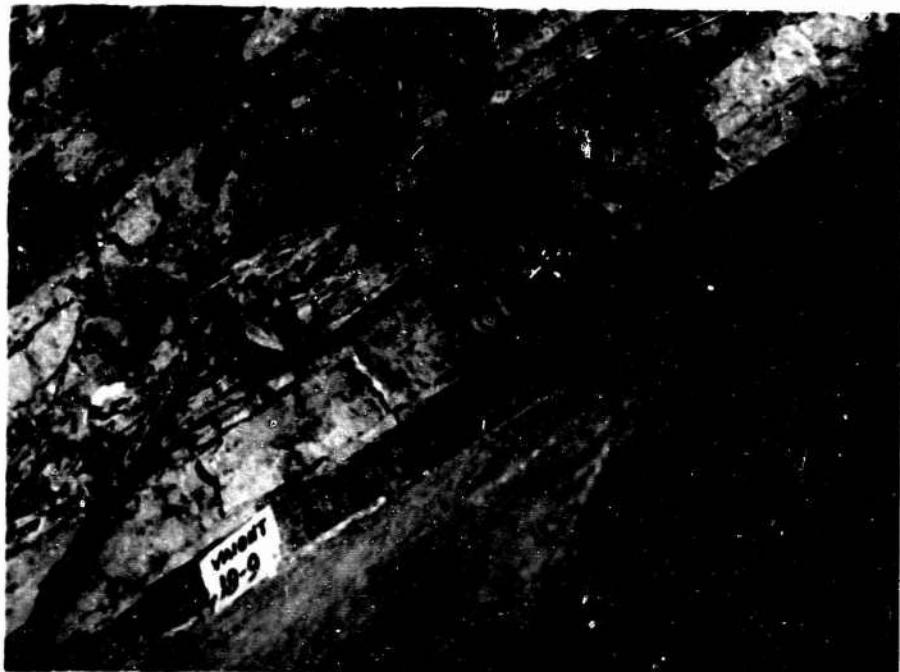
Photo 25. Location 18-9, below western third of headscarp; outcrop along edge of failure surface of 1963 slide or post-1963 slides; loose rock slabs cover clay interbed with dip of 35°N

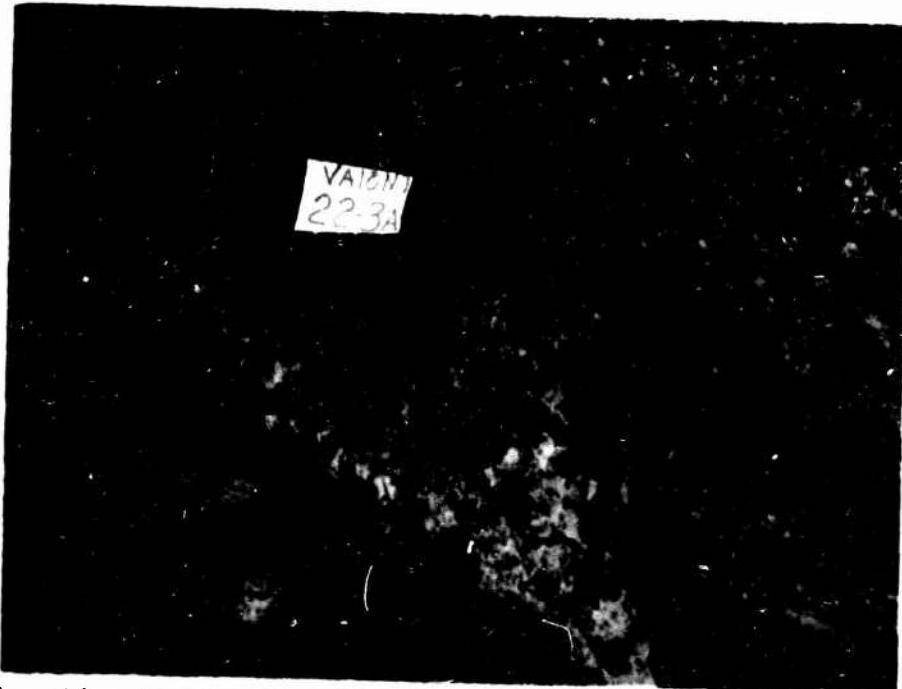
Photo 27. Location 22-3A, clay layer, 2 to 3 cm thick and continuous for 8 m, rests on 1963 surface of sliding; clay overlies 0.5 to 1.0 m of cemented breccia dipping at 45-48° N; dips of "bedding" and clay layers in slide debris above are flatter

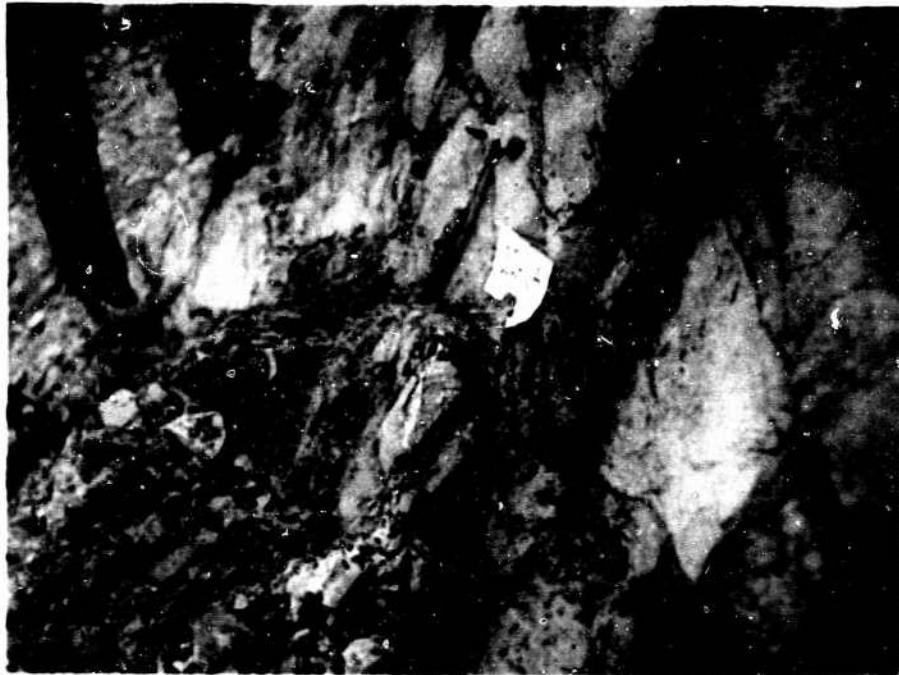
Photo 29. Location 22-6, west side of fifth gully from western edge of slide; clay layer 1 to 3 cm thick, which has been preserved along small fold with dip of 60° N, is associated with adjacent failure surfaces of 1963 slide

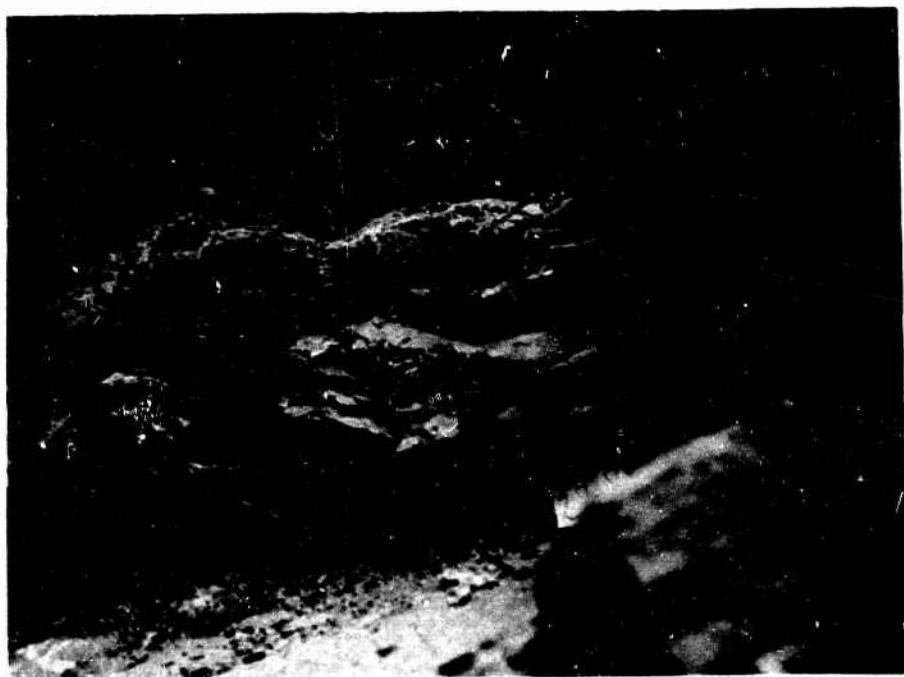
Photo 32. Location 22-7B; clay interbed 2 to 6 cm thick associated with adjacent failure surfaces of 1963 slide is protected by small flexure; clay dips at 65° N

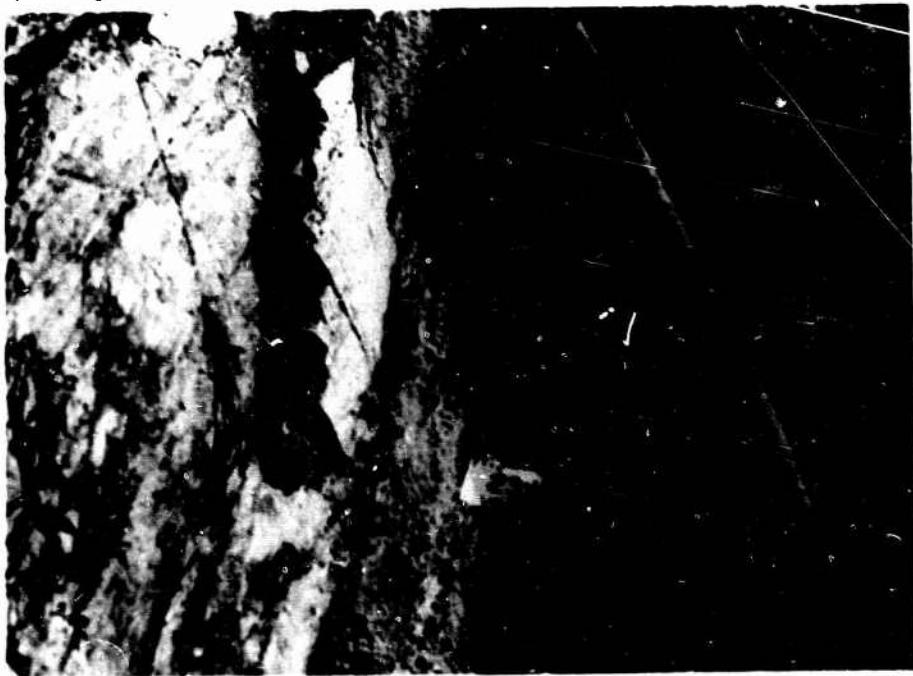
Photo 33. Location 22-8, east side of fifth gulley from west side of slide, one-third of the way up rock face; clay interbed 7 to 10 cm thick is associated with adjacent failure surfaces of 1963 slide; second clay interbed 1 to 3 cm thick is present in overlying beds; clay has weathered and eroded to leave opening

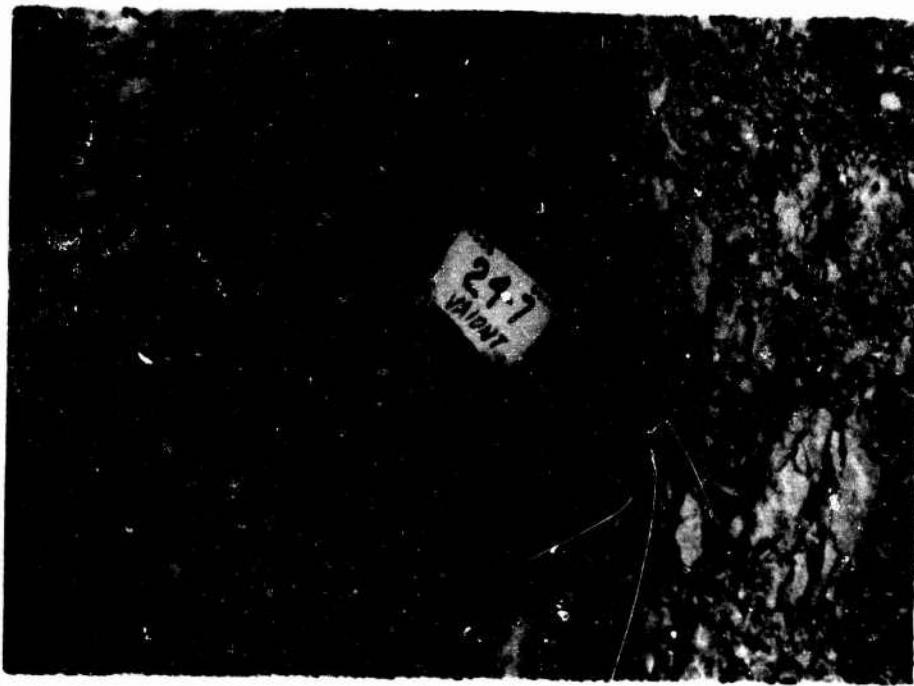
Photo 36. Location 24-3, third gully from east side of slide; several clay interbeds 1 cm thick are present in local fold below 1963 surface of sliding (at larger card); average dip of beds on failure surface above is 44° N

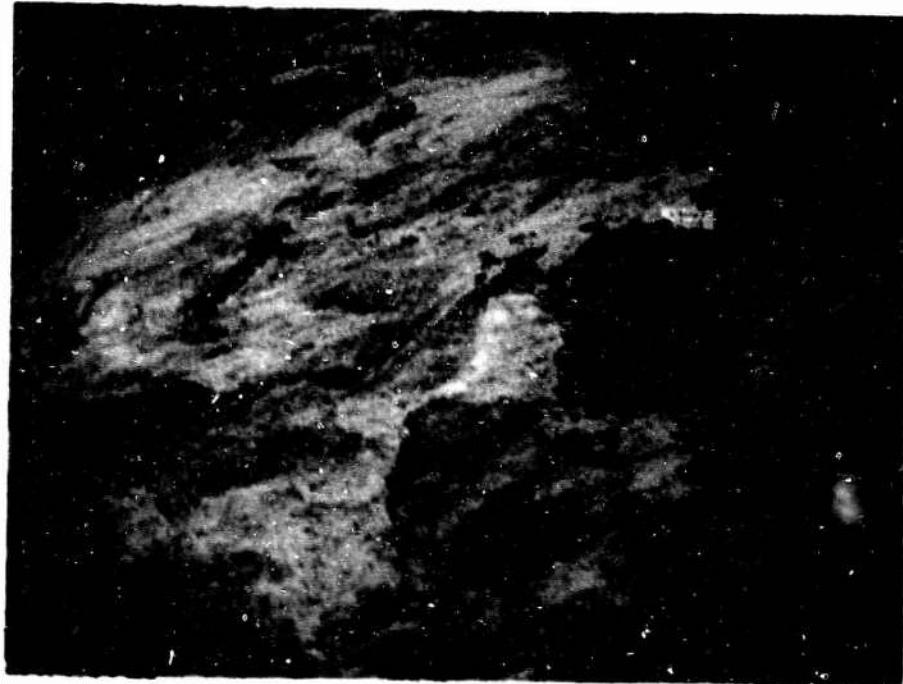
Photo 38. Location 12-1A, eastern surface of sliding; striations left by 1963 slide appear on surface of cemented breccia of possible tectonic origin; surface:strike 20° , dip 46° W; striations: 338° Az, plunge 30° N

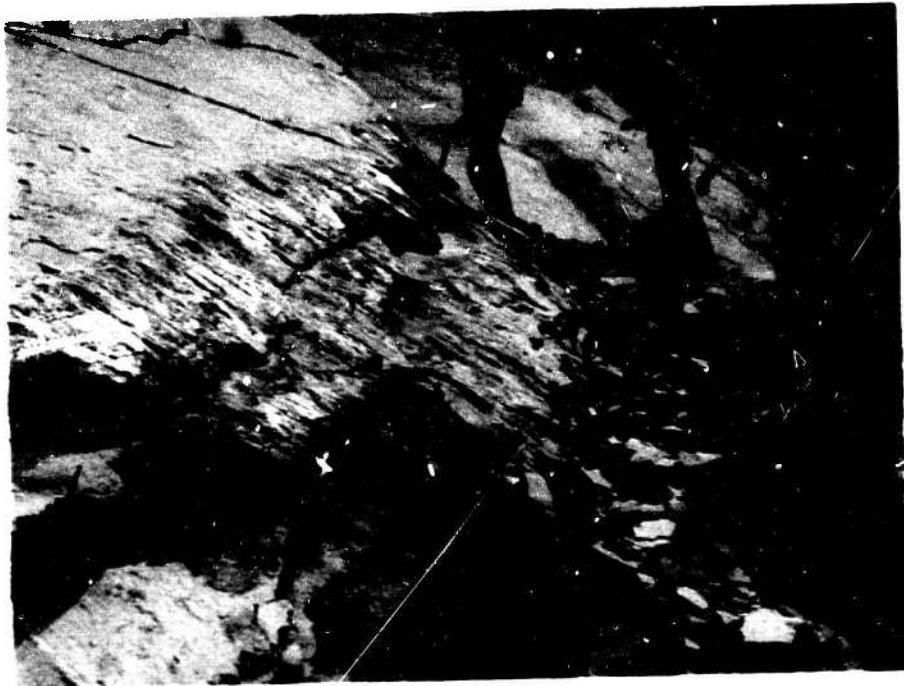
Photo 40. Location 12-3; striae believed caused by 1963 sliding of the Eastern Lobe appear in surface of cemented breccia; striae: 316° Az, plunge 20° NW

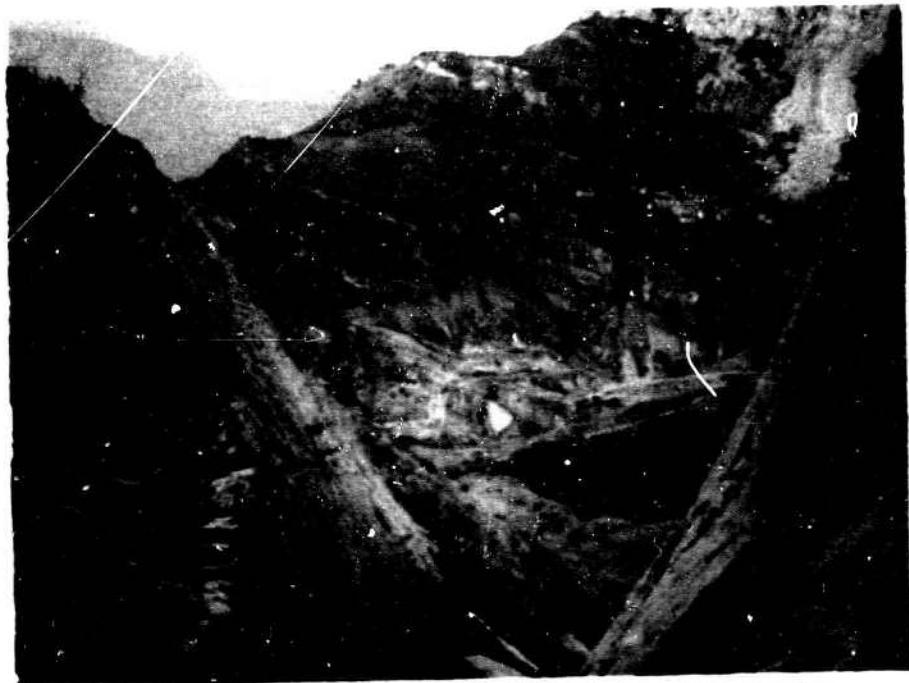
Photo 41. Location 18-10, below western headscarp; striations caused by 1963 slide or post-1963 slides cut across bedding which has a strike of 98° and dip of 30° N

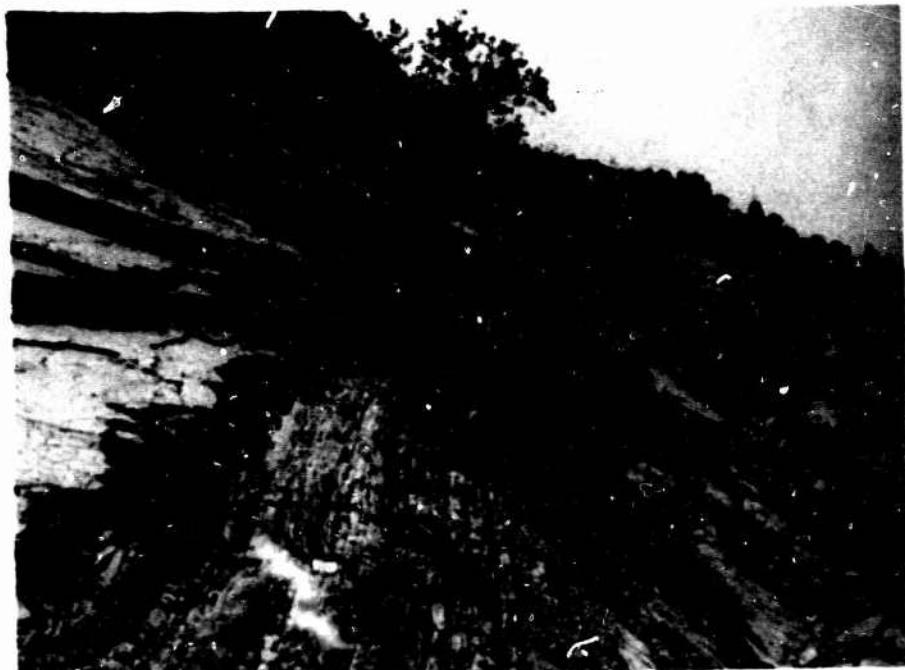
Photo 44. Location 22-1, fourth gulley from west end of surface of sliding; the 1963 slide exposed a section through a small cascade structure; base of remnant of slide debris is just above boulders in background

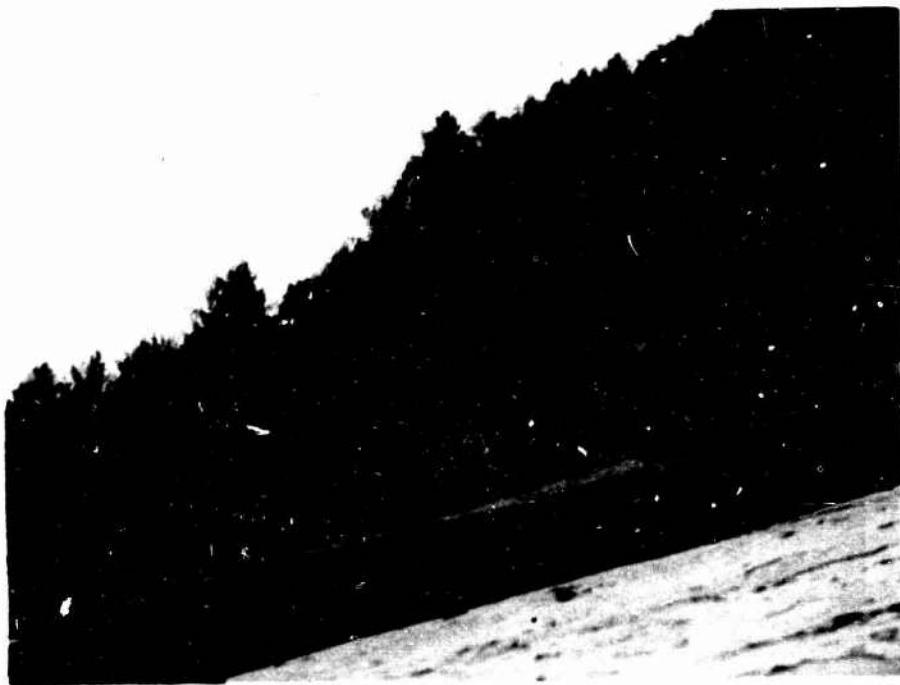
Photo 47. Location above 18-10; old vegetated headscarp is continuous with new 1963 headscarp; two or more types of cemented breccia have infilled old "bergschrund;" solution cavities in better cemented (older?) breccia are visible on the right

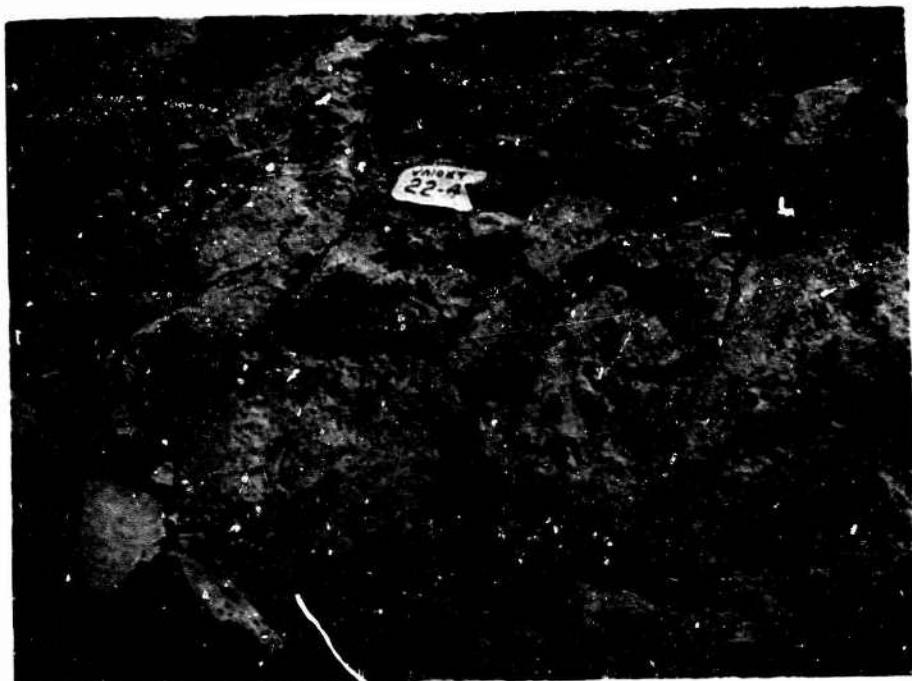
Photo 52. Location 22-4, eastern portion of slide just below surface of sliding; solution cavities 0.5 to 1.0 cm diameter developed along surface of sliding in cemented breccia of possible tectonic origin
